**ENGINEERING GEOLOGICAL CONTROLS ON FAILURE
MECHANISMS IN ROCK CUT-SLOPES IN THE TORLESSE
COMPOSITE TERRANE IN WELLINGTON, NZ**

Master of Science in Engineering Geology

University of Canterbury

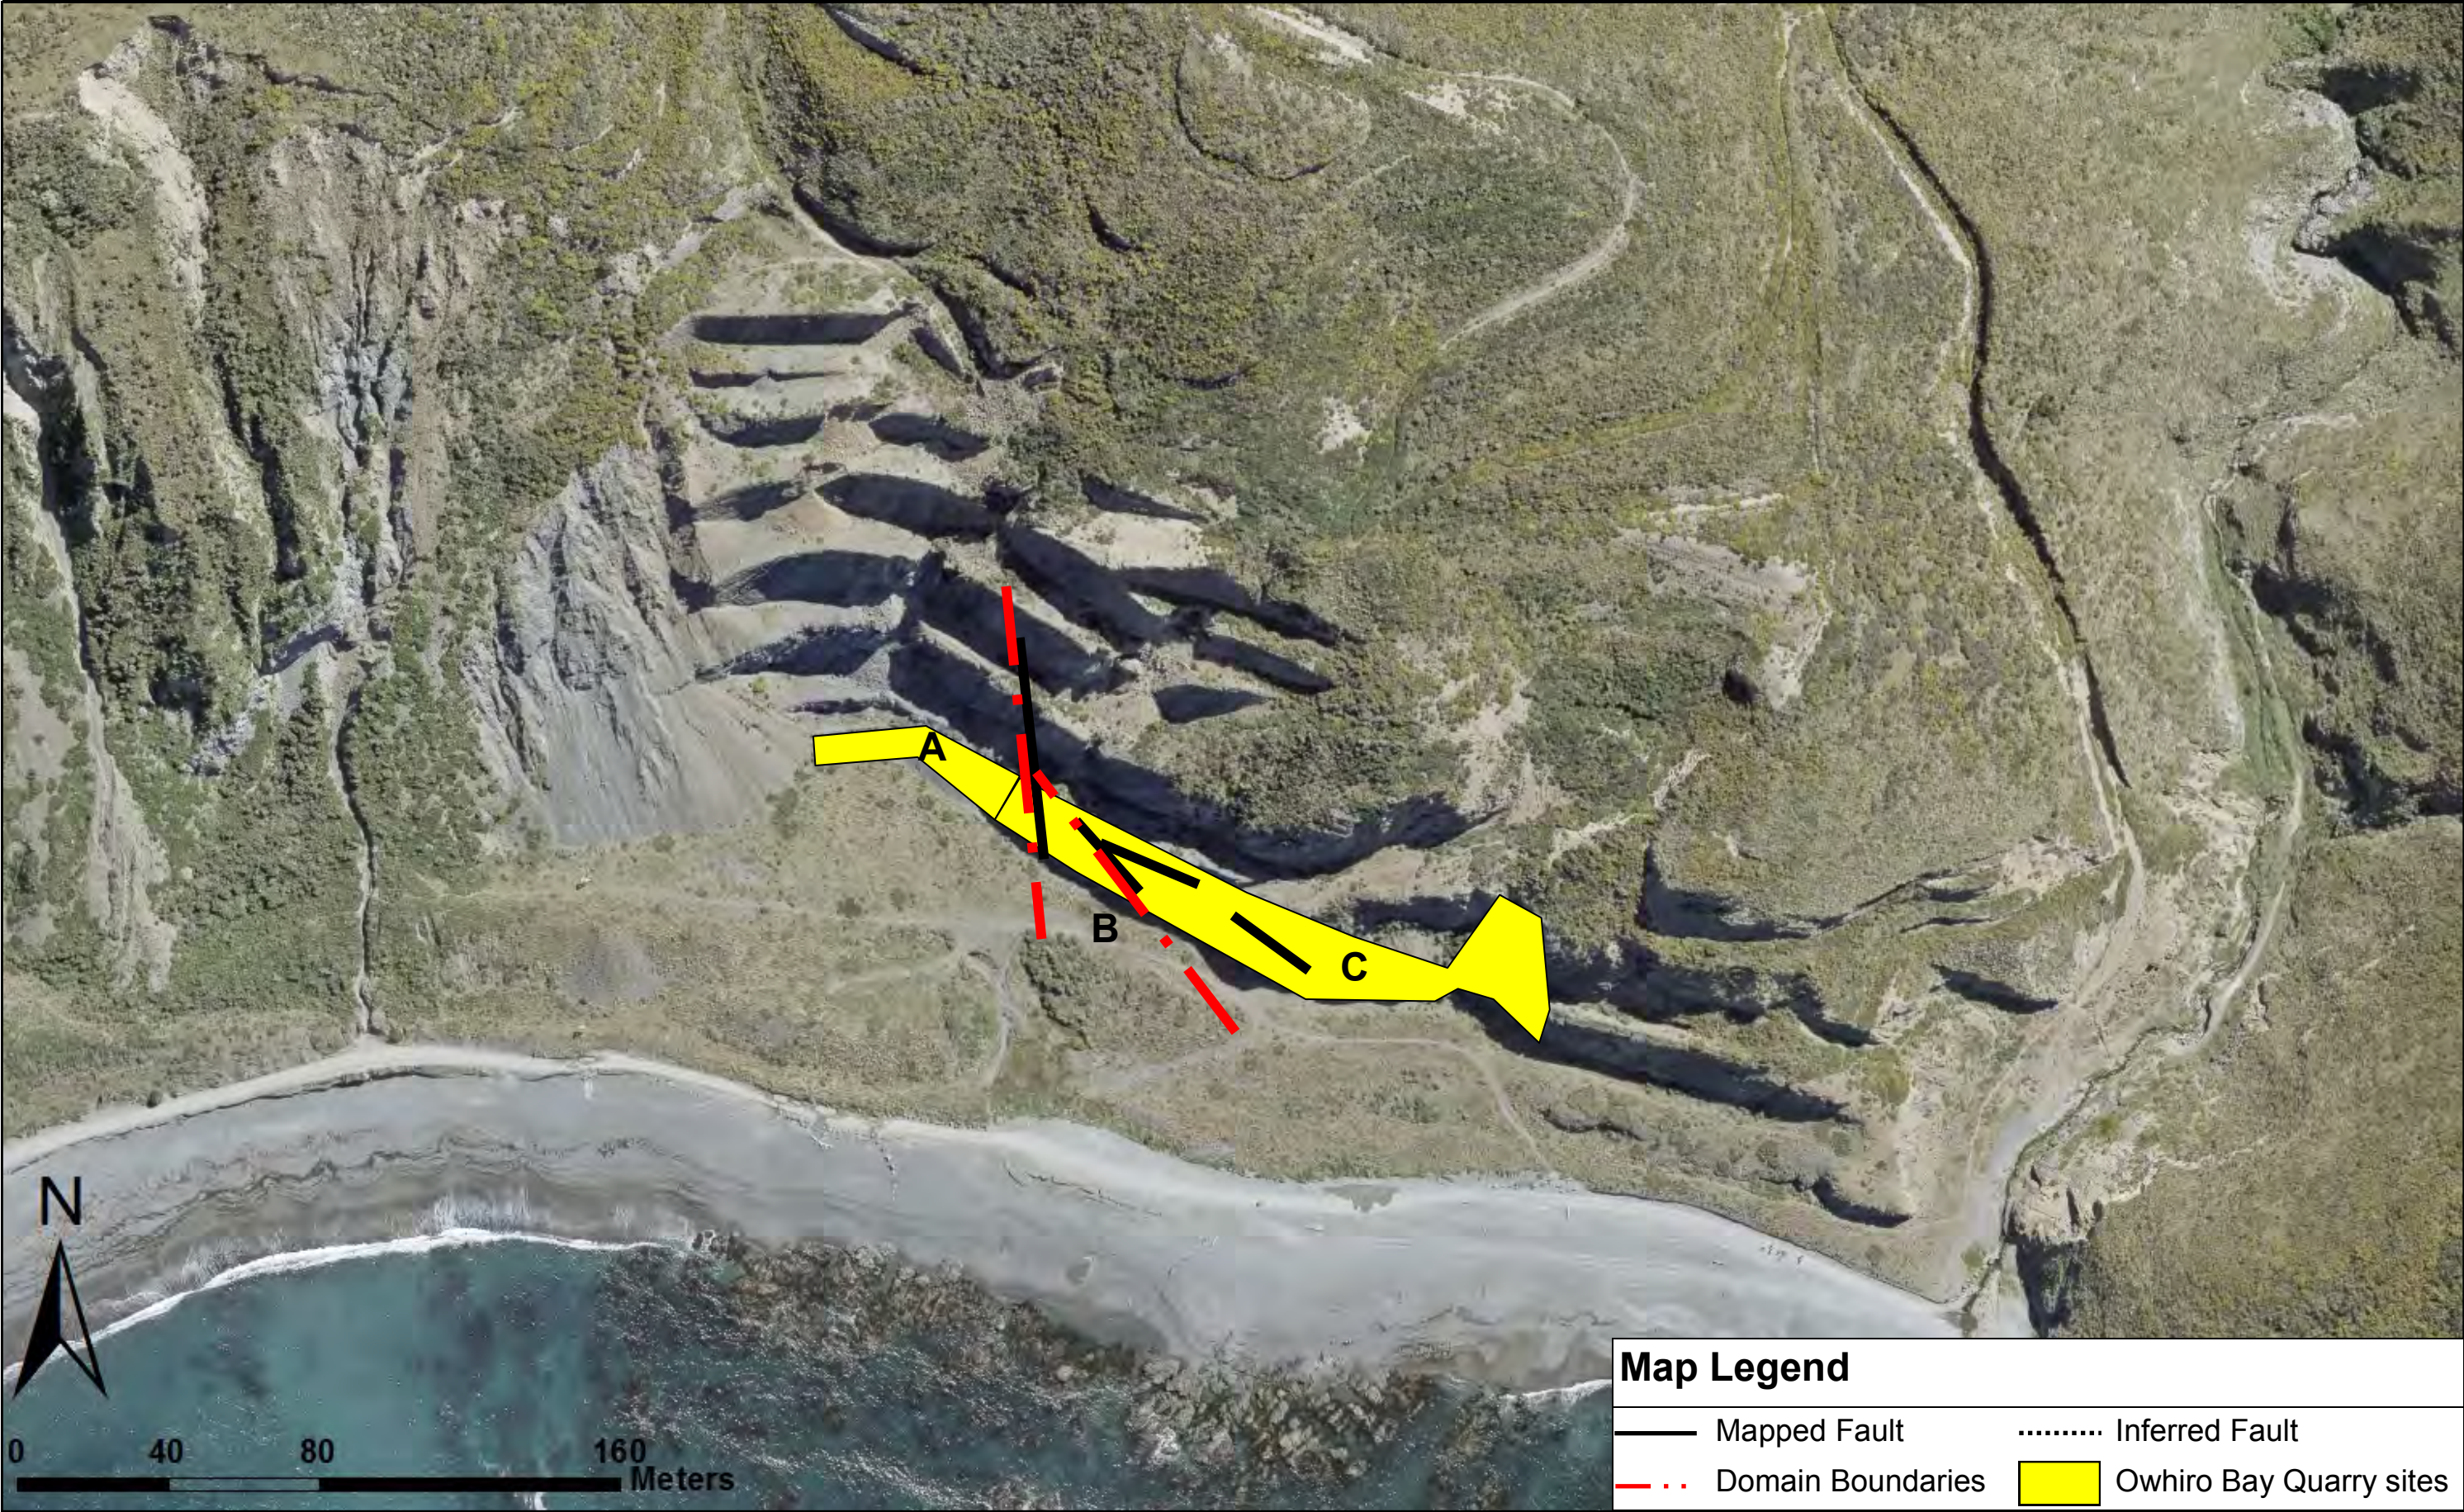
E.7.1 Owhiro Bay Quarry - Domains

Figures are based on mapping observations and stereonet analysis. The figures represent a very detailed interpretation of the changes in defect orientation across the Owhiro Bay Quarry site.
